HOME REPORT

75 LONGSTONE ROAD
EDINBURGH
EH14 2AX

Energy Performance Certificate (EPC)

Single Survey

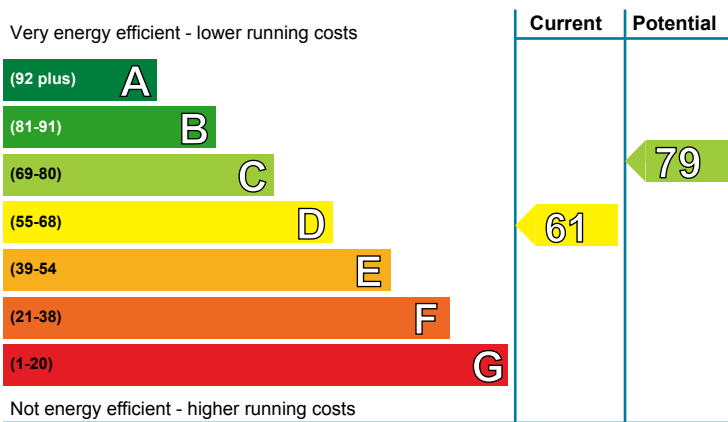
Energy Efficiency Rating

This graph shows the current efficiency of your home, taking into account both energy efficiency and fuel costs. The higher this rating, the lower your fuel bills are likely to be.

Your current rating is **band D (61)**. The average rating for EPCs in Scotland is **band D (61)**.

The potential rating shows the effect of undertaking all of the improvement measures listed within your recommendations report.

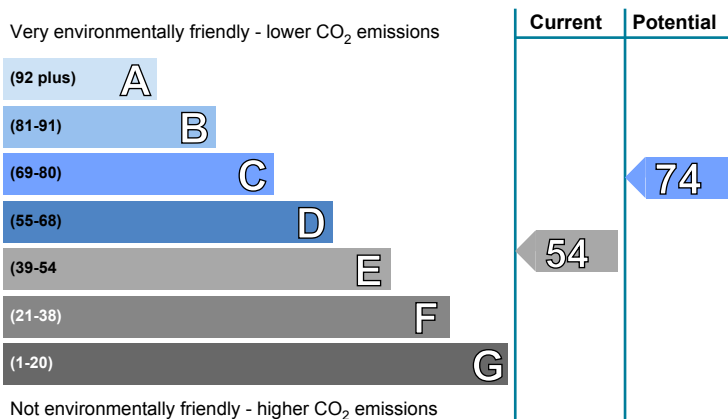
Environmental Impact (CO₂) Rating

This graph shows the effect of your home on the environment in terms of carbon dioxide (CO₂) emissions. The higher the rating, the less impact it has on the environment.

Your current rating is **band E (54)**. The average rating for EPCs in Scotland is **band D (59)**.

The potential rating shows the effect of undertaking all of the improvement measures listed within your recommendations report.
